## Lodi Primary School Facilities Assessment

PRA Project #07042  
4 September, 2007

School District of Lodi  
Lodi Primary School - Assessment

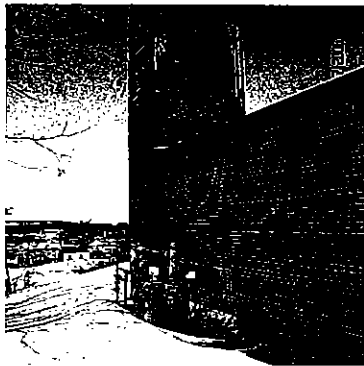
**1918:** The exterior walls that remain exposed are a terra cotta colored brick with dark random accents laid in a common bond pattern typical of the era. The walls have been patched in places with sections of mismatched brick, and have been tuck-pointed in some spots with a mismatched color mortar and even caulk in other locations. Other areas display deteriorated mortar joints in need of tuck-pointing. The windows in the boiler room appear to be original steel single glazed multiple lite units which are in below average condition. The exterior doors and frames are steel and are showing some corrosion near the bottoms. Some portions of the 1918 building have been covered with an exterior insulated finish system (EIFS) at some time in the early 1990's. The EIFS is in good condition. The roofing over the custodial and maintenance areas is a ballasted membrane, while the roofing over the boiler room is a built up type roof. Both roof types are in above average condition.

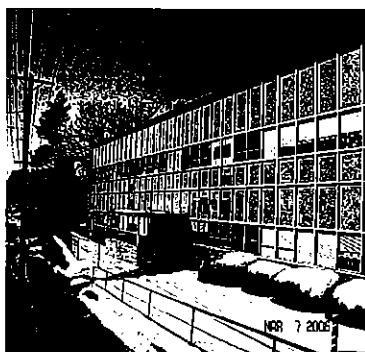
**1959:** The remaining exposed exterior walls are a combination of brick masonry and clear anodized aluminum curtainwall with clear glazed vision panels and enameled insulated steel spandrel panels. The brick color is a good match to the previous 1949 brick and is laid in running bond pattern. The brick work below the curtainwall shows a few spots of minor deterioration, but generally speaking is in good condition. The wide expanses of curtainwall on the south face of the building are an almost signature element of school building design from the late 1950's and 1960's. The condition of the system is good, although the thermal performance of the system, even when brand new, was poor. Exterior doors and frames are steel, are painted a pale blue color, and are showing some corrosion near the bottoms. The roof on this section of the building is a built up system and is in above average condition.

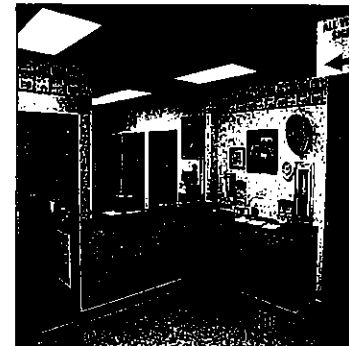
*Administrative Areas:* The administrative offices are immediately adjacent to and provide visual control of the building main entrance, although visitors are not forced through the office area. Included in this area are spaces for Work Room, Clerical Space, Principal's Office, Reading Specialist Office, Nurses' Office, Conference Room, Staff Toilet, Data Room, and Storage. Floor finishes are generally carpeting, with VCT in work room, nurse's office, and ceramic tile in the toilet room. The floor finishes are in above average condition. Ceilings are all suspended acoustical panels. The panels are in good condition. Wall finishes are vinyl faced modular demountable partitions, which are in good condition. All spaces are cramped. There is no dedicated "Time out" space.
